# The CADILLAC LA SALLE SERVICE MAN

Volume VII, Number 1 January 1, 1933

## Preliminary Information Released for New Car Announcement

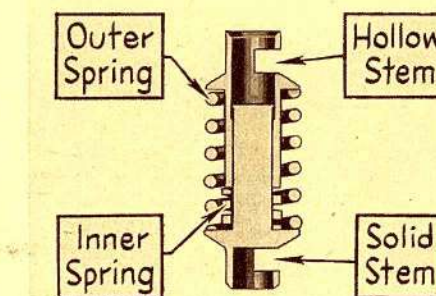
How to distinguish the two ends of the two-stage control valve. The single-stage type is similar except that it does not have the inner spring.

control valve which may be identified by the inner spring in addition to the outer spring, as shown in the illustration. By removing this valve, which is located under the control lever, and installing the control valve used in the shock absorber being replaced, the late type "C" series Cadillac shock absorbers may be used on all "B" and "C" series cars except the 345-C. The new 345-C shock absorbers may be used only on 345-C cars.

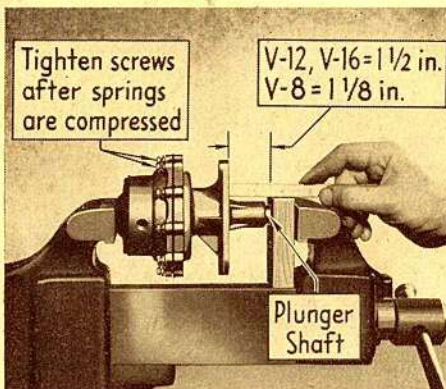
The screws should be tightened with the diaphragm under pressure obtained by compressing the plunger

A cracked or broken diaphragm in the vacuum pump will cause excessive oil consumption and it is therefore extremely important that the precautions above be taken when installing the diaphragm.

should then be placed in a vise, with a piece of wood to protect the end of the plunger shaft from damage, and the vise should be tightened to compress the springs to approximate their full tension in operation. This condition is obtained when the distance from the lower side of the pump base to the bottom of the plunger shaft is 1 1/2 in. on V-12 and V-16 cars and 1 1/8 in. on V-8 cars as shown in the illustration.

The screws should then be securely tightened. With this procedure there should be no danger of the diaphragm cracking in operation.

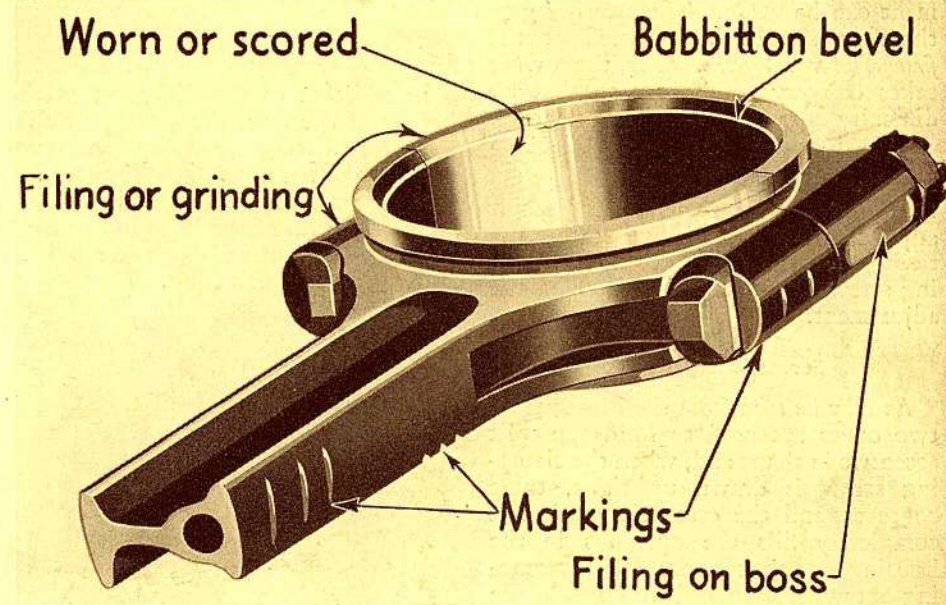
5. Excess of babbitt on the outside of the rod showing careless rebabbitting by outside repair shops.

Important points to watch in connecting rod inspection

In returning rods for rebabbitting, particular care should be taken to make sure the proper caps are installed on the rods.

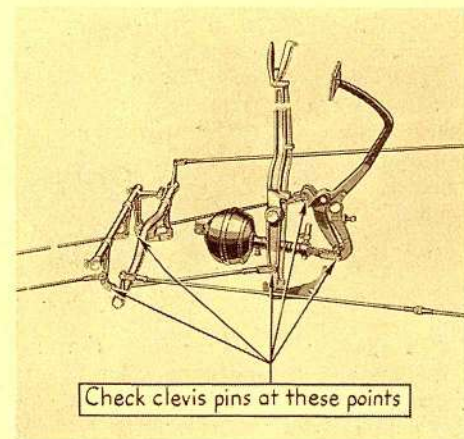
Closing a loose clevis and installing the spring washer will eliminate vibration at these points

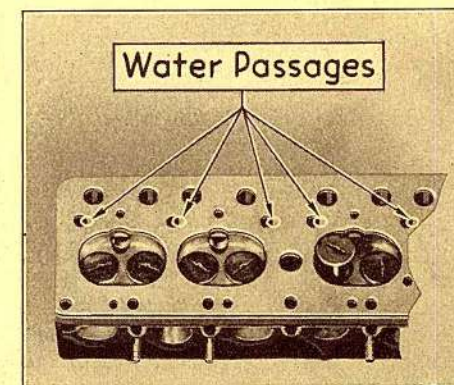
The water passages in the gasket should be inspected to make sure they line-up with the water passages in the cylinder head
