# The CADILLAC LA SALLE SERVICE MAN

Volume VII, Number 1 January 1, 1933

## Preliminary Information Released for New Car Announcement

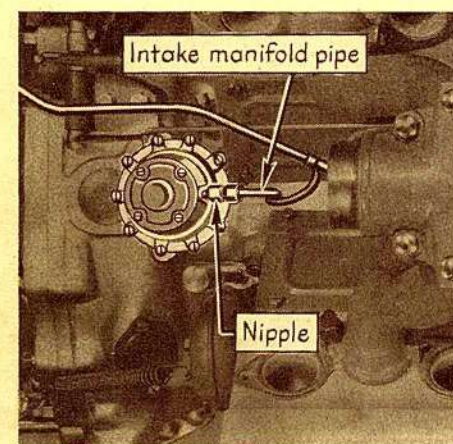
It is not necessary to remove the pump for this inspection. A cracked or a broken diaphragm means that oil is being pumped into the vacuum pump and in turn is being drawn out through the pipe line to the intake manifold. It is therefore possible to determine

The nipple may be removed after disconnecting the pipe to the intake manifold

whether or not the diaphragm is broken by inspecting the pipe connection leading to the intake manifold.

To make this test, disconnect the intake manifold pipe at the pump and look for oil. Next remove the nipple to which the pipe is connected in the head of the pump and look inside of the passage. If there is any trace of oil whatever in this nipple, the diaphragm is probably cracked or broken and the pump should be disassembled for further inspection. The slightest trace of oil in the nipple is sufficient evidence. The suction of the intake manifold draws the oil out of the vacuum compartment and through the pipe with such force that there is seldom likely to be more than a thin film of oil in the nipple.

Whenever any evidence is found of a cracked or broken diaphragm, it is extremely important to disassemble the pump and replace the diaphragm to avoid excessive oil consumption.

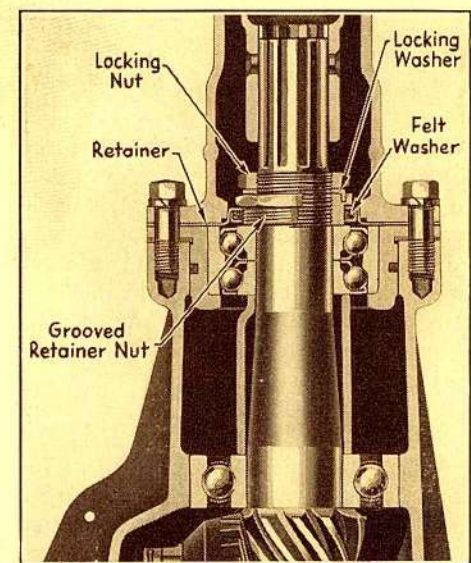
BEGINNING with rear axle unit number 30-4292 on "C" series cars, a new type of oil retainer is being used on the pinion shaft between the torque tube and the differential carrier. The new retainer is similar to the one furnished for earlier model cars but in-

The new retainer is spot welded at two points and the retainer nut has a special oil return groove

corporates several improvements. The new retainer assembly consists of a double plate spot welded at two points containing a felt washer, and a new bearing retaining nut with a spiral oil return groove cut in the outer surface.

It is also advisable to replace the cork gasket on the retainer for the front pinion bearing and, in cars which have the late type axle oil retainer described on Page 30, July 1, SERVICE MAN, the felt washer should be replaced. In this connection, whenever axle is down for inspection or replacement of gears, the retainer nut should be inspected and the grooved type installed whenever the plain type is found.

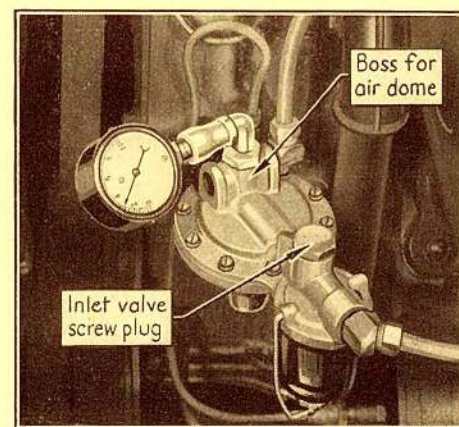
The pressure gauge should then be attached, screwing the connection nipple into the boss where the air dome has been removed, and screwing the gauge into the connection. It is important that the spring and fibre valve be in place when this test is made. Start the engine and note the pressure. If the diaphragm is not cracked or broken and the linkage springs have sufficient tension, the gauge should indicate from 2 to 3 pounds (the average is about 2 3/4 pounds) with the engine running. If the pressure is less than 2 pounds, the pump should be removed from the engine, disassembled and the diaphragm and springs inspected.

After inspecting the inlet and outlet valves, the pressure gauge should be attached and the pressure tested

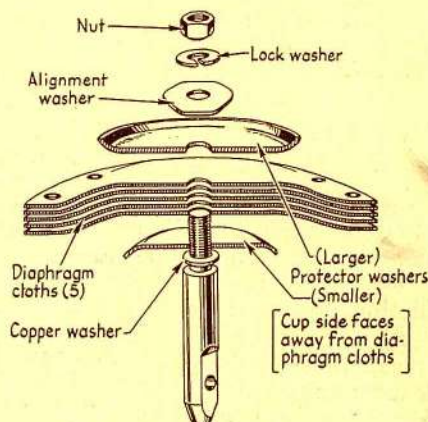
To remove the diaphragm after the pump has been removed from the engine, first mark the top cover and pump body so that they can be aligned properly when reassembling; then remove the ten screws in the top cover and take off the cover. If the diaphragm is cracked or broken or shows signs of excessive wear it should be replaced. The fabric alone may be replaced or the entire

The parts must be assembled in the proper order and position to permit proper operation and to avoid breakage

diaphragm assembly, including the pull rod, may be replaced. If the diaphragm is in good condition, the linkage springs should be replaced to correct insufficient pressure.

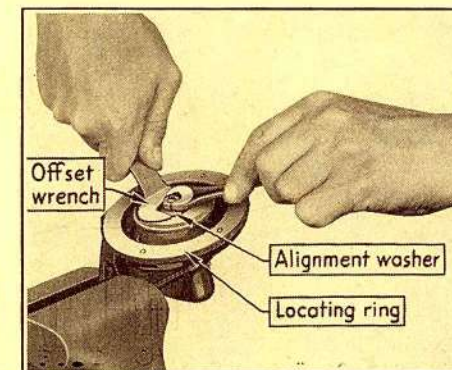
It is extremely important that the diaphragm be held exactly in alignment while the pull rod nut is being tightened. If it is allowed to twist or become distorted the life of the diaphragm will be considerably shortened. In this connection, if the entire diaphragm assembly, including the push rod, is replaced, it may be necessary to loosen the pull rod nut, place the diaphragm cloth in the proper position and, holding it with the locating ring, tighten the pull rod nut in the same manner as above before installing the top cover.

The alignment washer should be held with the offset wrench while the diaphragm nut is tightened

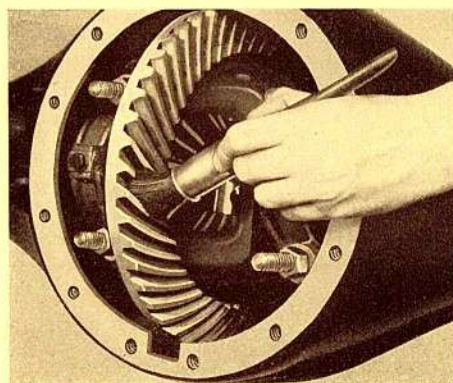
The meshing of the gears can best be determined by painting the working surfaces of the ring gear teeth with a light coat of red lead thinned with gasoline, as shown in the illustration, or with Prussian blue. When the gears are turned the red lead or Prussian blue is wiped off at the point where the teeth of the ring gear and pinion mesh.

Turning the ring gear several revolutions *by hand* will give the tooth contact under light load. It is important to make this light load test first so that an initial adjustment can be made if the gears are not correctly meshed. The tooth form may easily be ruined by running the gears under load when not correctly meshed.

The meshing of the gears can best be checked by painting the gear tooth surfaces with a light coat of red lead and turning the gears.

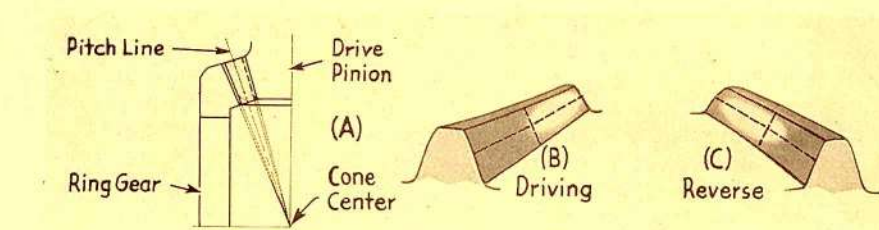
Fig. 2 Correct Ring Gear Tooth Contact

The desired tooth contact for both driving and reverse is shown in Figure 2B and C on this page. This contact is suitable from the standpoint of both lengthwise and profile contact and if the backlash is within the proper limits the gears are in need of no further adjustment.

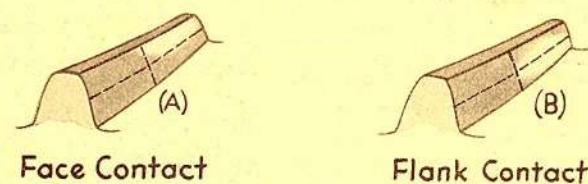
Fig. 5

The required adjustment is determined by the position of the tooth contact. The line drawings in this illustration show the reason for the variations in the contacts.

tooth, as shown in Figure 3 (B) and (C) respectively, increase the backlash between the gears, keeping it under .012 in., however, by moving the ring gear away from the drive pinion. This may also change the profile or top-to-bottom contact slightly which should be corrected by adjusting the pinion as explained later.

To correct a heel contact on both the driving and reverse sides of the tooth, illustrated in Figure 4 (B) and (C) respectively, move the ring gear toward the drive pinion. This will increase the lengthwise contact but may also change the profile contact slightly. It will decrease the backlash also, and this should be checked to see if it is within the minimum limit of .004 inch.

To correct a low profile or flank contact, move the drive pinion away from the ring gear by increasing the total thickness of the shims. This adjustment will increase the backlash and it may be necessary to move the ring gear toward the drive pinion to keep the backlash within the limits. Changing the position of the ring gear will alter the lengthwise contact on the tooth and to obtain correct tooth contact, illustrated in Figure 2 (A) and (B), several adjustments for lengthwise and profile contact, may be required as explained later.

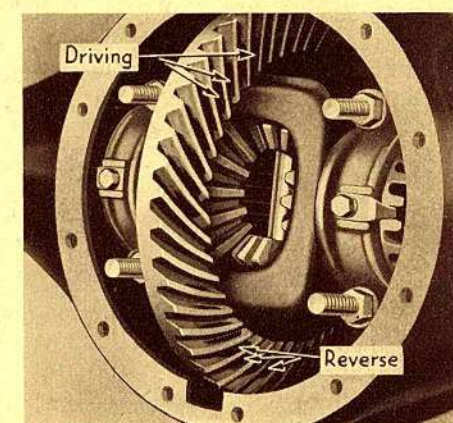
After the ring gear has been painted with red lead and turned a few times, the tooth contact can be seen.

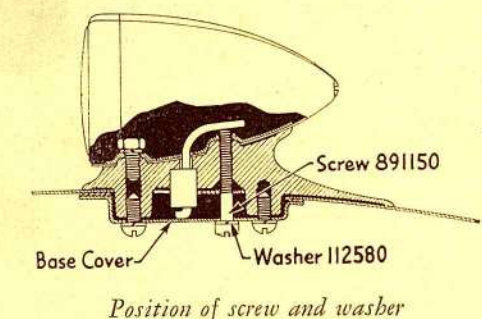
In case of poor contact at this point on 355, 370 and 452 "B" and "C" cars, the longer screw can be installed to provide an additional point of contact. To make the installation it is necessary to remove the lamp by removing the two screws in the bottom cover on the under side of the fender and locate and drill a  $\frac{5}{16}$  in. hole in the bottom cover, using the lamp-base as a template.

The longer screw, part number 891150, can then be placed through the bottom cover from the underside of the fender and through the fender and lamp base into the lamp. A washer, Part No. 112580, should be placed between the head of the screw and the bottom cover.

When installing the cover screws, it is important to draw them up tight to prevent moisture from entering.

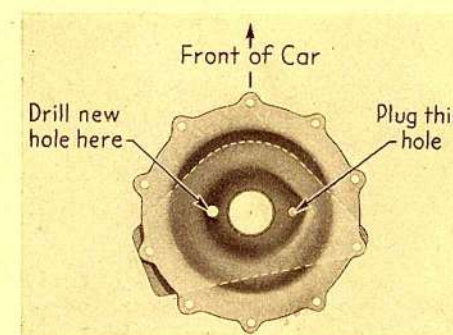
The developments include an improved diaphragm, a lighter spring for use above the diaphragm and the relocation of the vent hole in the lower pump body. The necessary parts for making these changes may be obtained from the Parts Division under assembly number 1521501 which includes the new diaphragm, spring and a plug for the original vent hole. The use of a cork gasket, part number 877852, also may be required to correct oil leakage between the flange of the pump body and the crankcase.

The position of the vent hole should be changed only on V-8 cars.

The vent hole in the lower pump body of vacuum pumps on V-8 cars should be plugged with the brass ball

furnished in the assembly, peening the body over the ball to hold it in place.

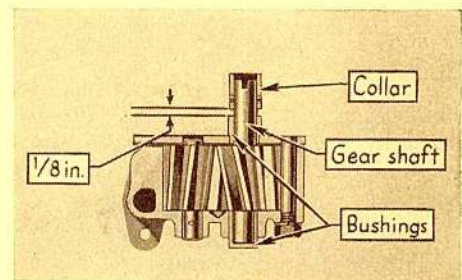
The gear shaft is a press-fit in the pump gear and should extend through the gear and into the lower bushing. If it is pressed too far into the gear it may not join properly with the drive shaft, resulting in excessive wear on the joint and, in time, rendering the pump in-operative. In some cases the bushing might be pushed out of the oil pump housing. If the shaft is not fitted deep enough it may bind.

The distance between the top of the upper bushing and the lower edge of the gear shaft collar should be approximately 1/8 in.

In order to make sure that the shaft is fitted properly it should be measured. The distance between the top of the upper bushing and the lower edge of the gear shaft collar, as shown in the illustration, should be approximately 1/8 in. This applies to all V-8 models from 303-341 up to the present.

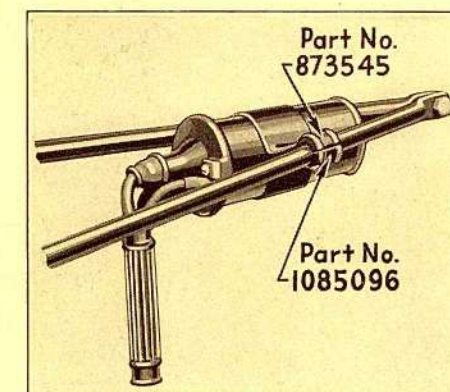
The coil may be mounted between the radiator tie rods using the bracket furnished for "A" series V-8 cars

The brackets furnished for mounting the coil between the radiator tie-rods on "A" series cars may be used for this installation on "B" and "C" series cars. These may be obtained from the Parts Division under part number 873545 for the upper bracket and part number 1085096 for the lower bracket, including the necessary screws. These brackets clamp the coil and attach to the radiator tie-rods as shown in the illustration.

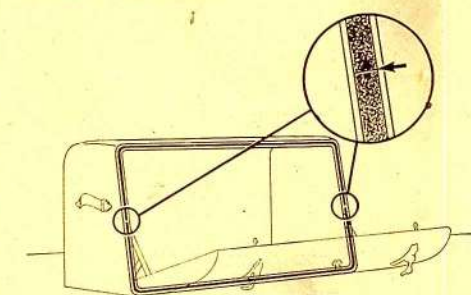
When the ends meet at the top and bottom there is a possibility of water standing and, if the joint is pulled, gradually seeping inside the trunk. If the joints are at the side, however, any water will drain off outside the trunk without having an opportunity to seep through the joint.

The joinings may be recognized as a thin line of cement in the stripping which should be located at the sides of the trunk

In any cases where the joints are found at the top and bottom, the rubber stripping should be pulled out, rotated 90 degrees so that the joints come at the sides of the trunk, as shown in the illustration, and pushed into place. This can be done in a few minutes time.

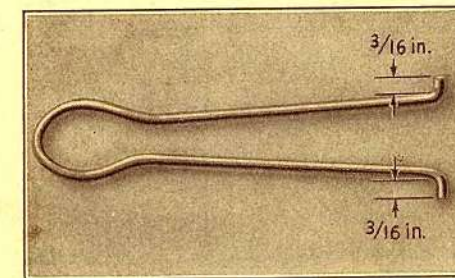
The tool can be made of spring steel wire bent as shown

When tightening this packing, the gland nut should be drawn up very tight, backed off, and again drawn up to a point where it just touches the packing. If this procedure is followed, the packing will be forced into a water-tight position without too much friction on the shaft. On the 452-C and late type 370-C pumps, particularly, the shaft is  $\frac{1}{8}$ " smaller than on previous types and sufficient tightness can be obtained with much less shaft friction.

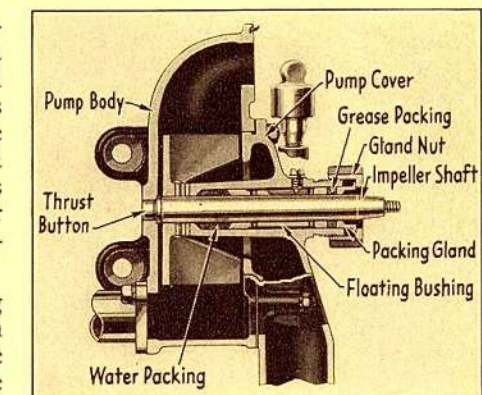
In case of a water leak which is not corrected when the water packing is in good condition and properly tightened,

The water packing on the new type water pump may be reached by removing the pump cover

the radiator overflow pipe should be inspected to make sure it has not become clogged. A clogged overflow pipe may result in pressure being built up in the cooling system sufficient to force water through the packing.

To reach the packing, remove the screws holding the cover to the pump body and remove the cover along with the entire impeller assembly. Next, remove the gland nut and the packing gland, and pull out the shaft from the impeller side of the cover. Loosen the set screw holding the floating bushing. The floating bushing may then be pulled out with the spring puller and the water packing will be accessible. The cover may be assembled in the reverse of these instructions.

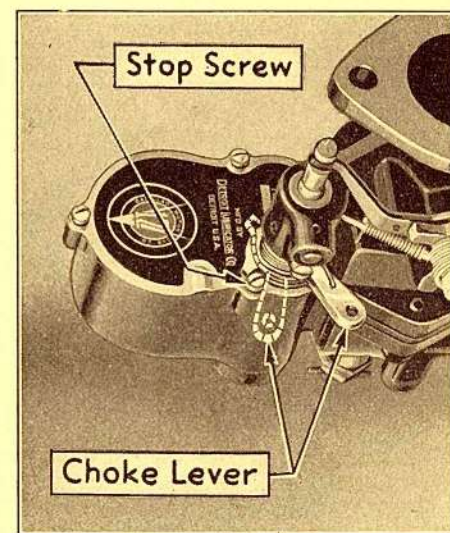
Full movement may be prevented by the rocker shaft levers striking the

The choke lever should strike the stop screw in both open and closed positions

dash. This ordinarily can be corrected by lengthening or shortening the adjustment between the instrument panel control rod and the rocker shaft lever. In rare cases, the angle between the rocker shaft levers may be too great, causing interference with the dash whether the control button is in or out. In such cases the center lever may be moved on the shaft to increase the possible movement of the levers.

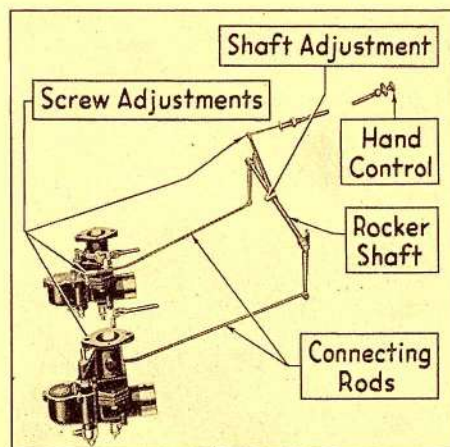
The control rod adjustments may not be the same on both carburetors, preventing full closing on one carburetor and full opening on the other. This can be remedied by equalizing the adjustments of the control rods so that both will be in the same extreme positions at the same time.

The arrangement of the choke control on V-12 and V-16 cars
